# **The Landmark Village Planning Area Oak Tree Report Los Angeles County, California**

**September 2006**

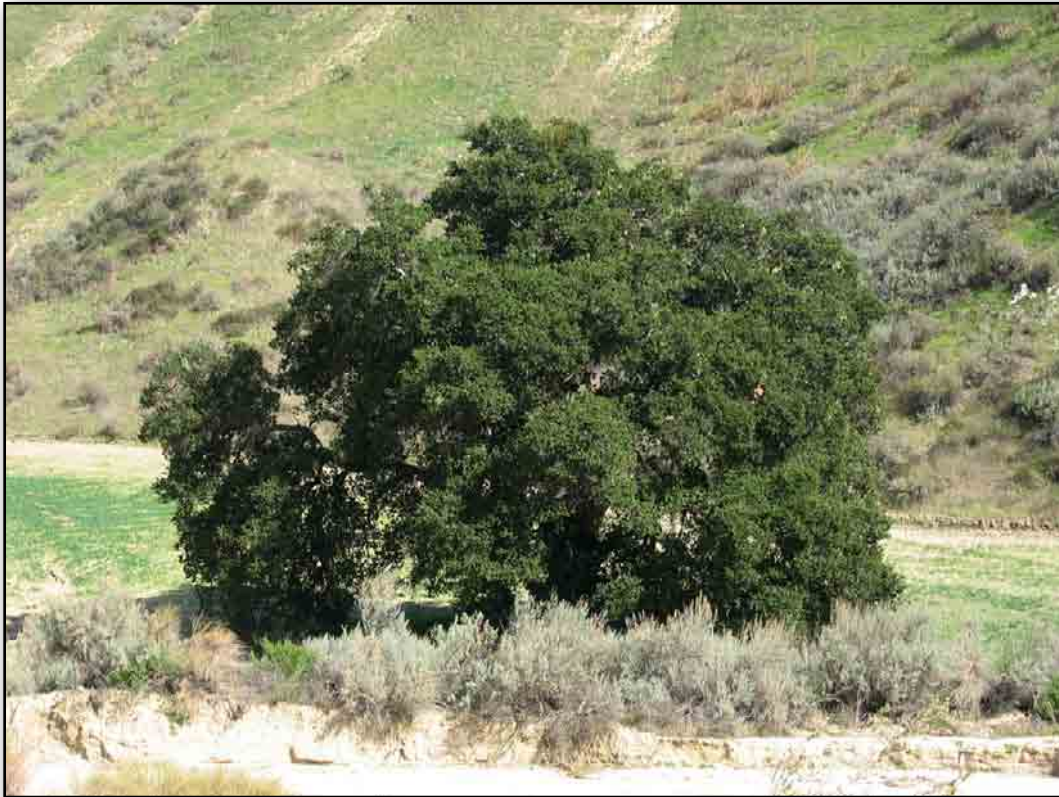
**Figure 5** – Tree # 489 – Coast Live Oak tree with all “A” Grades (Vigor, Health, Aesthetics, Balance)

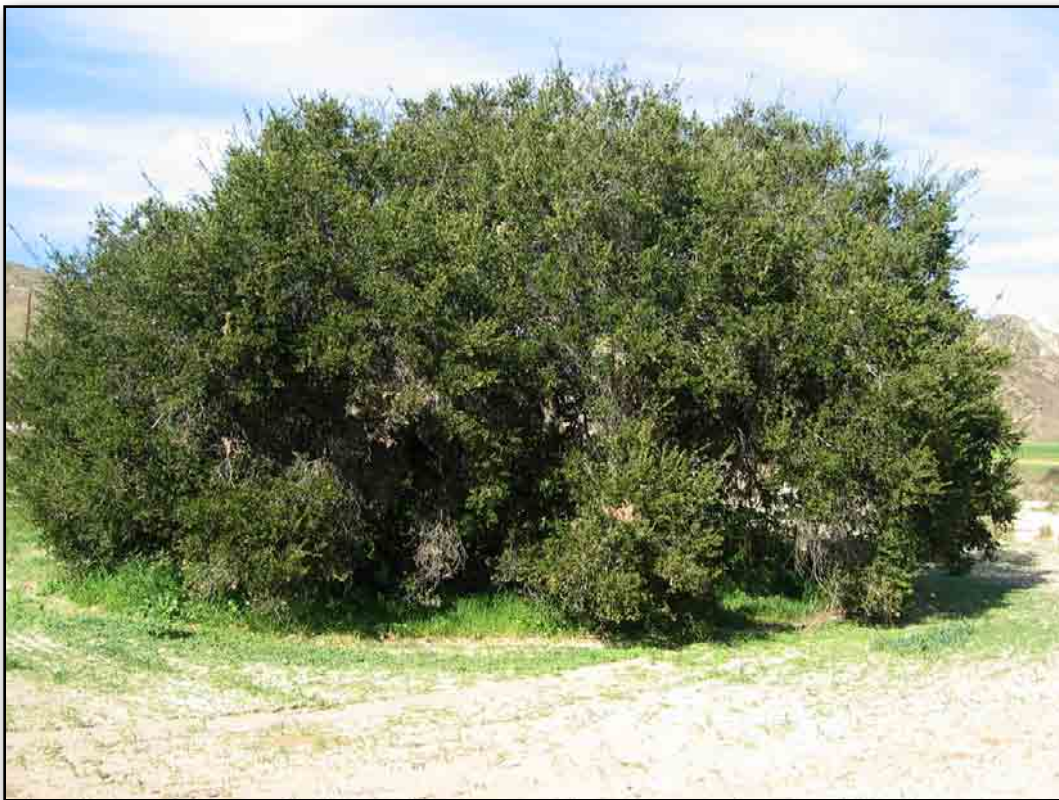
**Figure 6** – Tree # 454 – Coast Live Oak tree with all “B” Grades (Vigor, Health, Aesthetics, Balance)

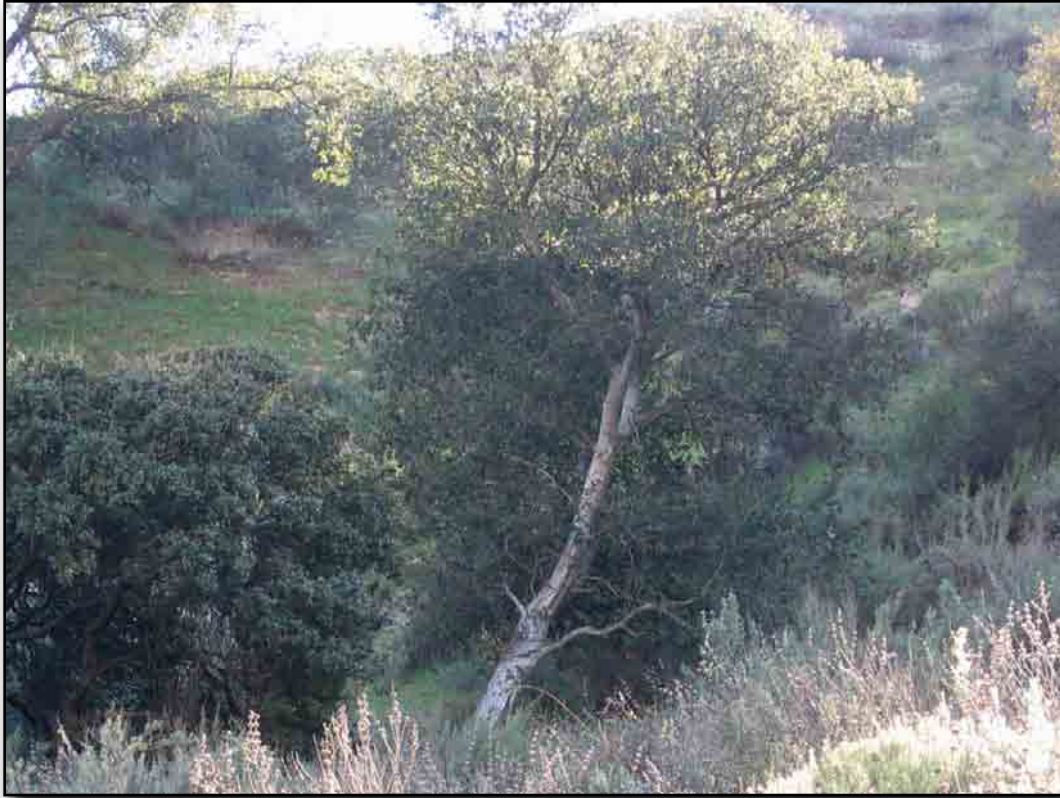
**Figure 7** – Tree # 61 – Coast Live Oak tree with all “C” Grades (Vigor, Health, Aesthetics, Balance)

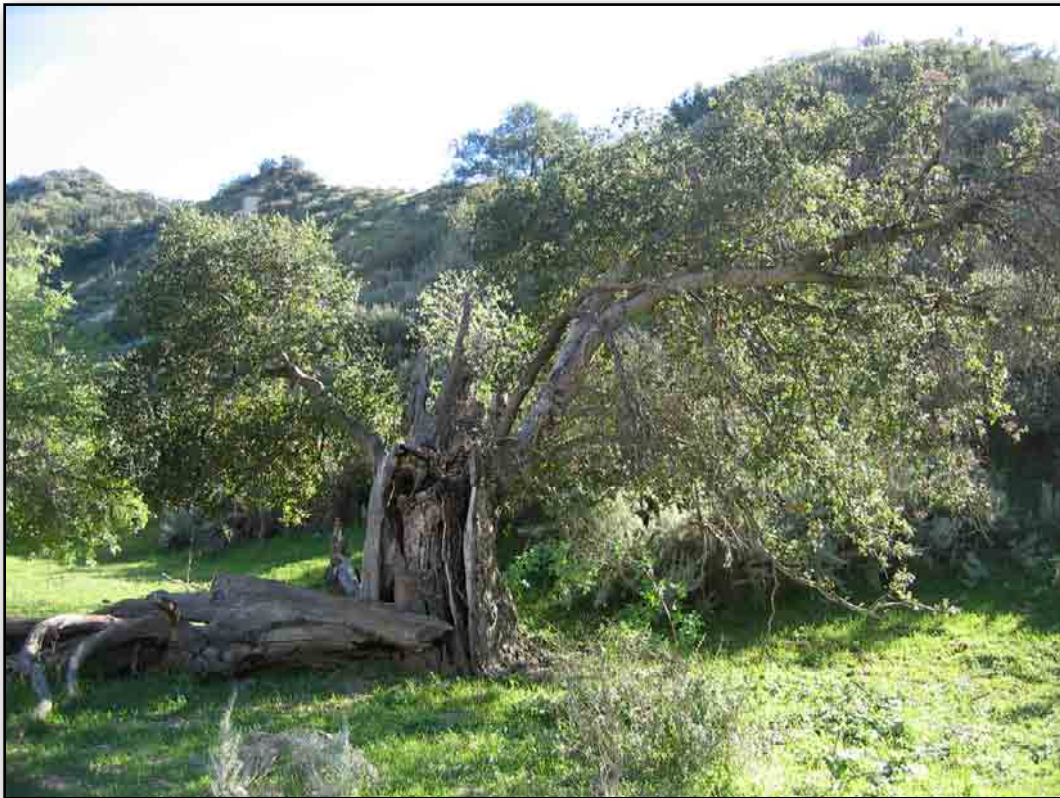
**Figure 8** – Tree # 338 – Coast Live Oak tree with all “D” Grades (Vigor, Health, Aesthetics, Balance)

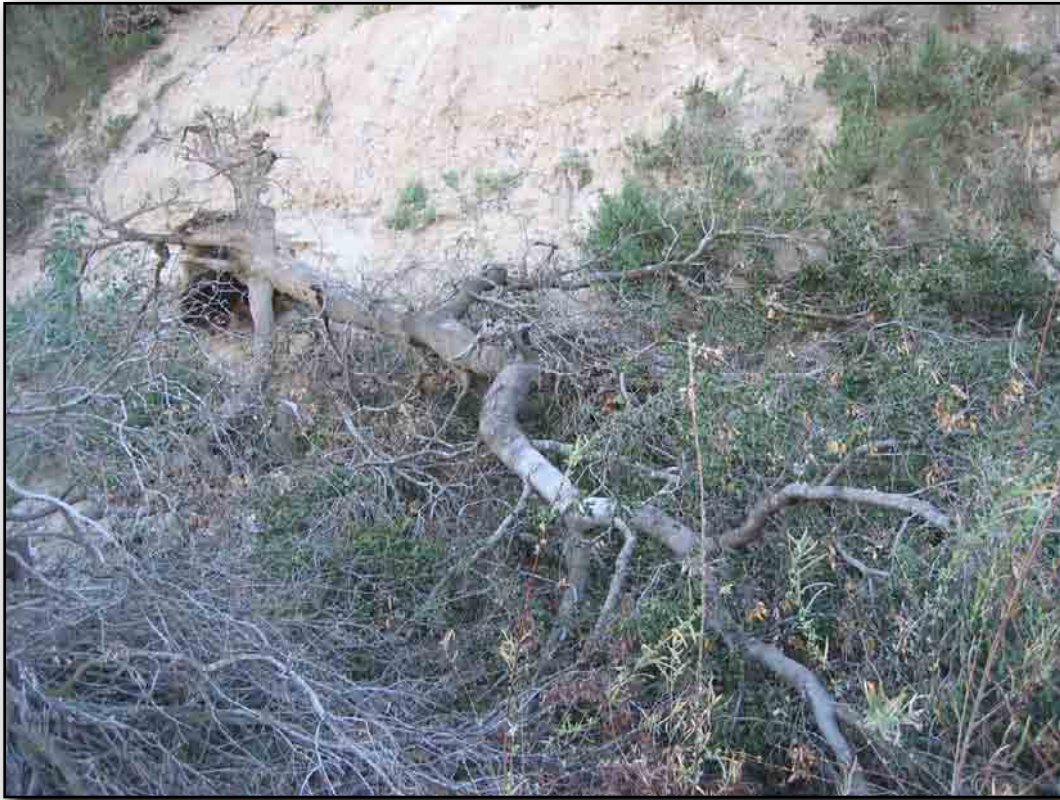
**Figure 9** – Tree # 26 – Coast Live Oak tree with all “E” Grades (Vigor, Health, Aesthetics, Balance)

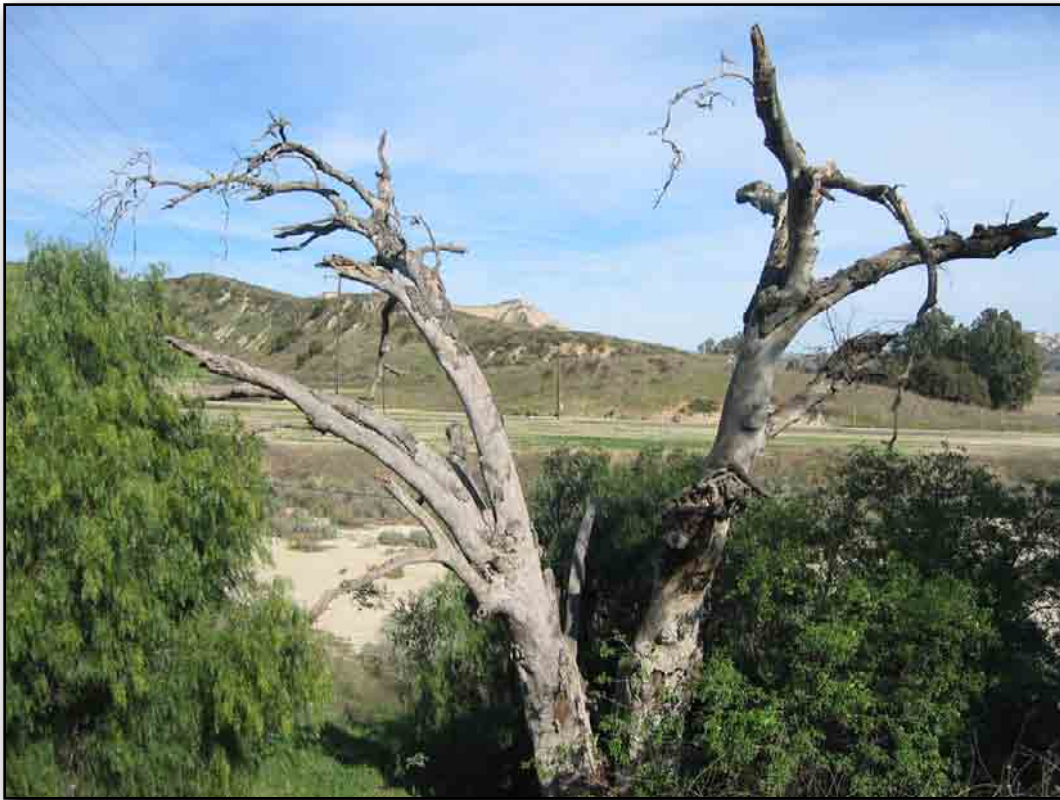
**Figure 10** – Tree # 585 – Coast Live Oak tree with all “F” Grades (Vigor, Health, Aesthetics, Balance)
